FACILITY CONDITION ASSESSMENT

Fullerton Joint Union High School District

Fullerton Union High School
201 East Chapman Avenue
Fullerton, California 92832

October 30, 2023

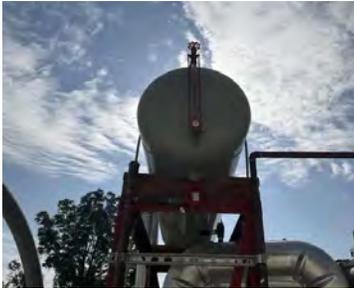
Boiler Supplemental Components in Poor condition.

Expansion Tank
Auditorium 002 - Fullerton Union High School
Building exterior

Moderate corrosion present on entire surface area. - AssetCALC ID: 6877032

Uniformat Code: D3020
Recommendation: **Replace in 2024**

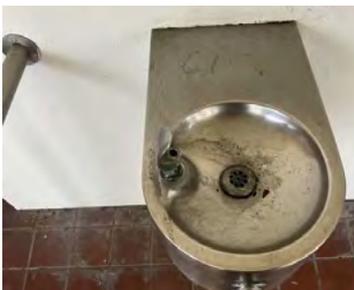
Drinking Fountain in Poor condition.

Wall-Mounted, Single-Level
Auditorium 002 - Fullerton Union High School
Building Exterior

The Water fountains are significantly stained over 100% of the drain pan and drain opening. - AssetCALC ID: 6877044

Uniformat Code: D2010
Recommendation: **Replace in 2023**

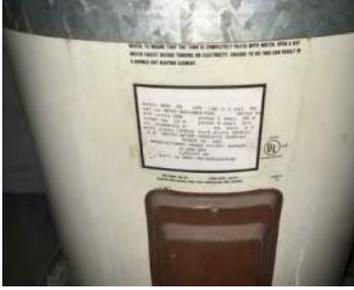
Water Heater in Poor condition.

Electric, Residential
 Auditorium 002 - Fullerton Union High School
 Mechanical Mezzanine

There is moderate corrosion present on bottom of storage tank. - AssetCALC ID: 6877024

Uniformat Code: D2010
 Recommendation: **Replace in 2023**

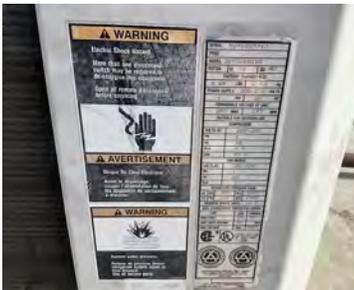
Split System in Poor condition.

Condensing Unit/Heat Pump
 Auditorium 002 - Fullerton Union High School
 Roof

The condenser coil is moderately dented from weather and age. - AssetCALC ID: 6877036

Uniformat Code: D3030
 Recommendation: **Replace in 2023**

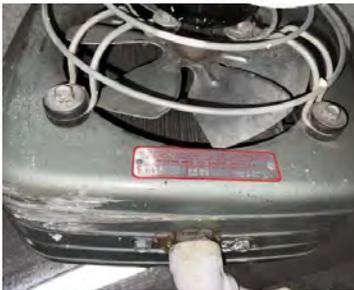
Unit Heater in Poor condition.

Hydronic, 13 to 36 MBH
 Auditorium 002 - Fullerton Union High School
 Mechanical room

There is moderate corrosion present on both supply and return piping unions. - AssetCALC ID: 6877052

Uniformat Code: D3020
 Recommendation: **Replace in 2023**

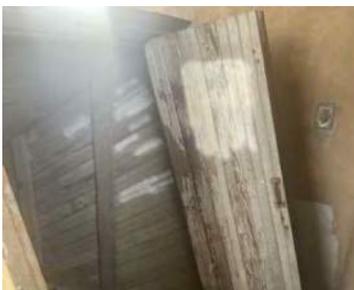
Exterior Door in Poor condition.

Wood, Solid-Core
 Auditorium 002 - Fullerton Union High School
 Roof

Clock tower door appears to be deteriorated. - AssetCALC ID: 6836920

Uniformat Code: B2050
 Recommendation: **Replace in 2024**

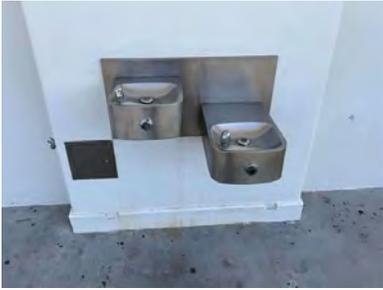
Drinking Fountain in Poor condition.

Wall-Mounted, Bi-Level
Business 50-58 002 - Fullerton Union High School Building exterior

The drinking fountains are severely stained throughout entire drain basin. - AssetCALC ID: 6878071

Uniformat Code: D2010
Recommendation: **Replace in 2023**

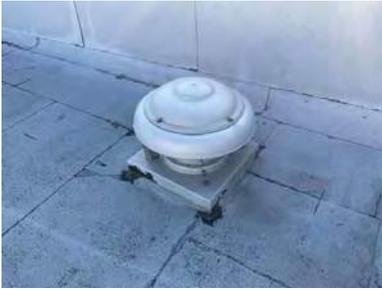
Exhaust Fan in Poor condition.

Roof or Wall-Mounted, 24" Damper
Cafeteria 002 - Fullerton Union High School
Roof

Uniformat Code: D3060
Recommendation: **Replace in 2023**

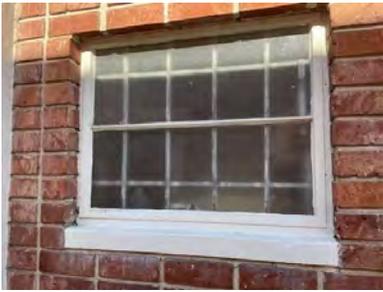
Glazing in Poor condition.

any type, by SF
Classrooms 60-76 002 - Fullerton Union High School Building Exterior

The glazing is original to the building and is showing moderate signs of distress due to age. - AssetCALC ID: 6878001

Uniformat Code: B2020
Recommendation: **Replace in 2023**

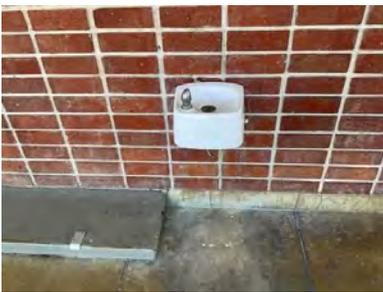
Drinking Fountain in Failed condition.

Wall-Mounted, Single-Level
Classrooms 60-76 002 - Fullerton Union High School Building exterior

Uniformat Code: D2010
Recommendation: **Replace in 2023**

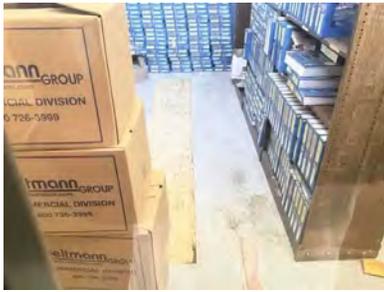
Flooring in Poor condition.

Vinyl Tile (VCT)
 English 30-47 002 - Fullerton Union High
 School Storage room

VCT flooring appears to be in poor condition. - AssetCALC ID: 6838402

Uniformat Code: C2030
 Recommendation: **Replace in 2024**

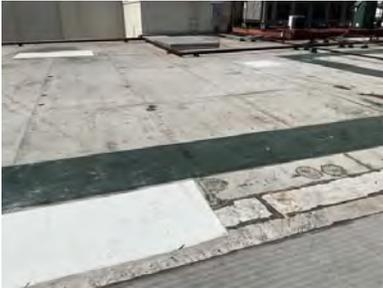
Roofing in Poor condition.

Single-Ply Membrane, EPDM
Fine Art/Little Theatre 002 - Fullerton Union
High School Roof

Uniformat Code: B3010
Recommendation: **Replace in 2025**

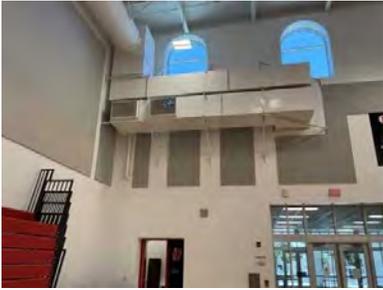
Recommended Follow-up Study: Mechanical, HVAC Controls/Rebalance

Mechanical, HVAC Controls/Rebalance
Gym 002 - Fullerton Union High School
Throughout building

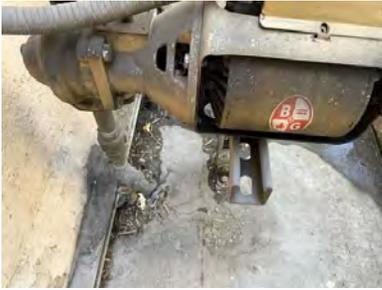
Pump in Poor condition.

Distribution, HVAC Heating Water
Locker Rooms 002 - Fullerton Union High School Building exterior

The circulation pumps are severely corroded primarily on motor housing flange. - AssetCALC ID: 6878300

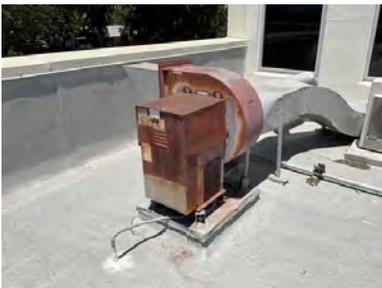
Exhaust Fan in Poor condition.

Industrial Dust Collection, 1 to 1.5 HP Motor
Locker Rooms 002 - Fullerton Union High School Roof

The fans are completely corroded with rust on all external steel components. - AssetCALC ID: 6878314

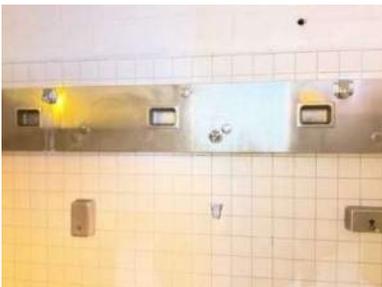
Shower in Poor condition.

Ceramic Tile
Locker Rooms 002 - Fullerton Union High School Restrooms

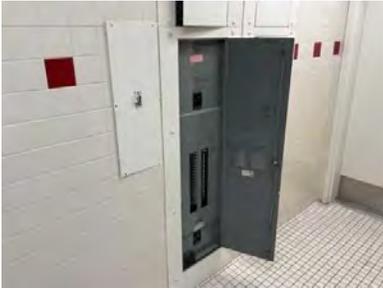
Distribution Panel in Poor condition.

120/240 V
Office 002 - Fullerton Union High School
Restrooms

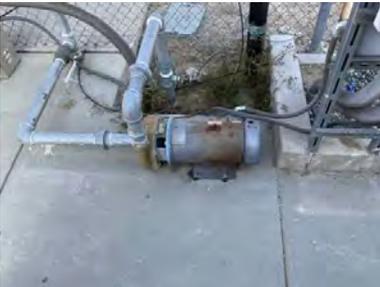
Supplemental Components in Poor condition.

Fire Jockey Pump
Site 002 - Fullerton Union High School Site

The jockey pump is severely corroded over 100% of the surface area. - AssetCALC ID: 6878453

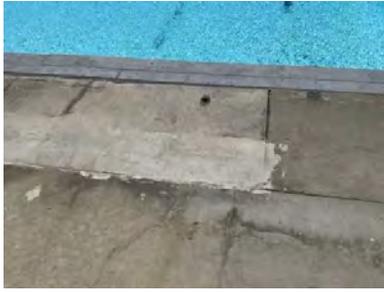
Pool Finishes in Poor condition.

Basin and Deck Finishes, Concrete Deck
Site 002 - Fullerton Union High School Pool

The pool deck material has moderate deterioration forming near water edge. - AssetCALC ID: 6878475

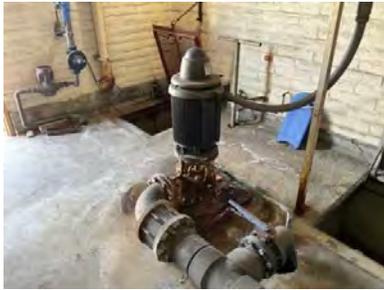
Pool Equipment in Poor condition.

Circulation Pump
Site 002 - Fullerton Union High School Pool

The pump is completely corroded over 100% of the surface area. - AssetCALC ID: 6878500

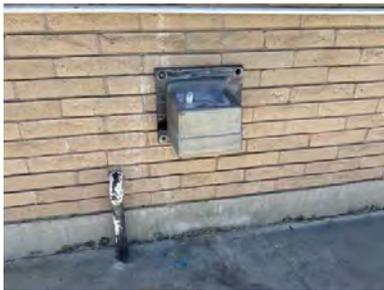
Drinking Fountain in Poor condition.

Wall-Mounted, Single-Level
Site 002 - Fullerton Union High School Pool

The drinking fountains are completely operationally impaired. - AssetCALC ID: 6878483

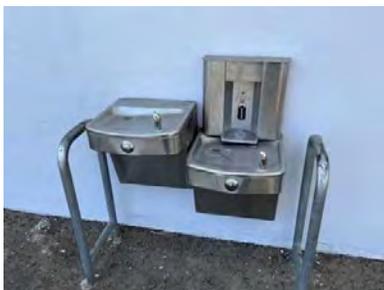
Drinking Fountain in Poor condition.

Wall-Mounted, Bi-Level
Site 002 - Fullerton Union High School Site

The drinking fountain is moderately corroded on all stainless steel cabinet parts. - AssetCALC ID: 6878477

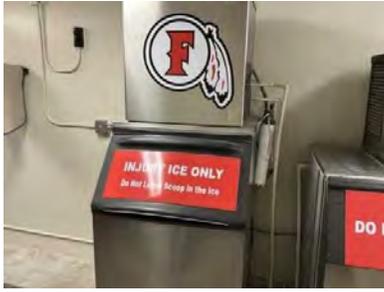
Foodservice Equipment in Poor condition.

Icemaker, Freestanding
Site 002 - Fullerton Union High School Stadium
