FACILITY CONDITION ASSESSMENT

Fullerton Joint Union High School District

Fullerton Union High School
201 East Chapman Avenue
Fullerton, California 92832

October 30, 2023

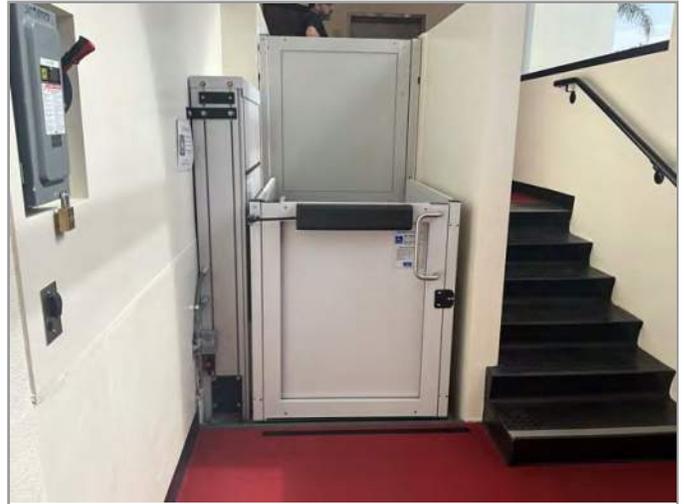
ADA LIFT

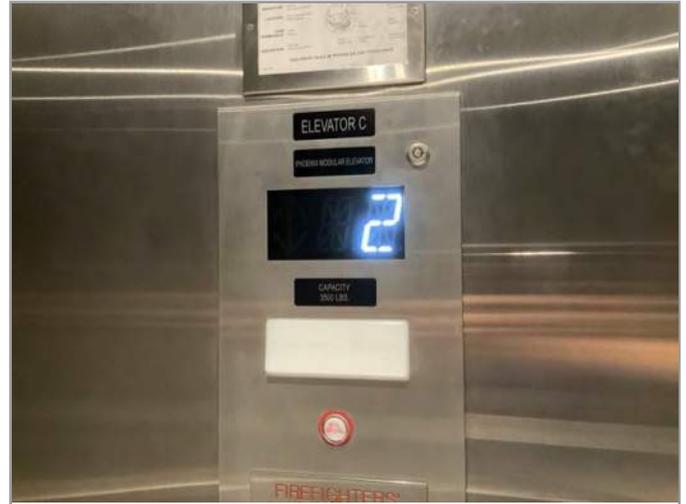
IN-CAB CONTROLS

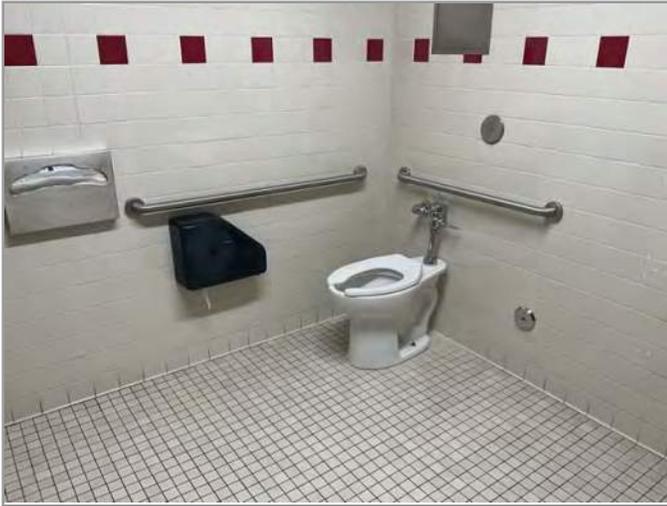
TOILET STALL OVERVIEW

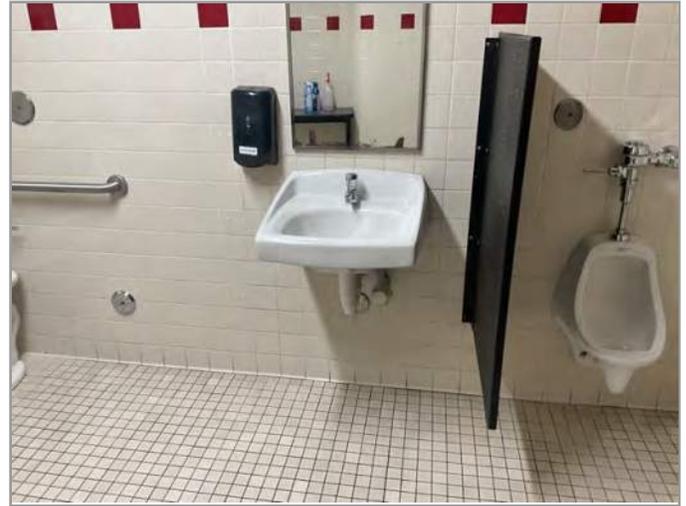
SINK, FAUCET HANDLES AND ACCESSORIES

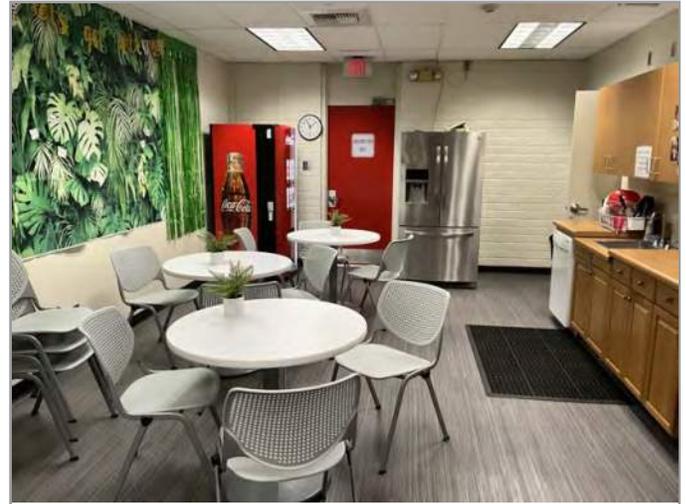
BREAKROOM OVERVIEW

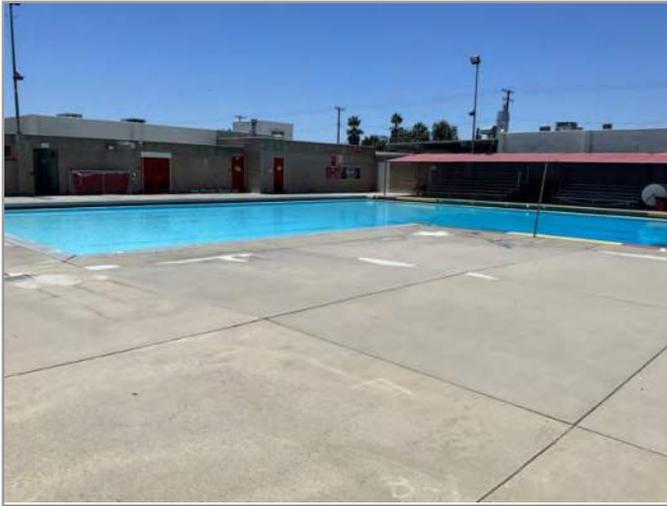
ACCESSIBLE ROUTE TO POOL

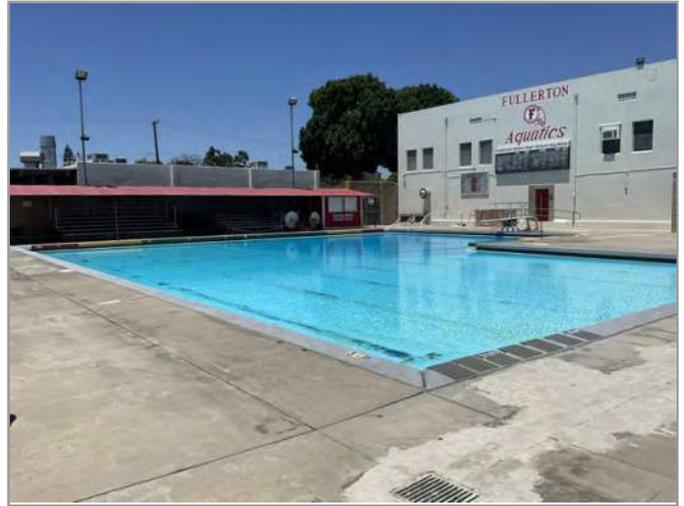
OVERVIEW OF POOL
